Client/Project
 City of Hamilton
 BUT-North Hamilton Crossing; PID 115755
 Level 1 Ecological Survey Report

Level 1 Ecological Survey Report

BUT-North Hamilton Crossing, PID 115755
Previously Studied Alternatives, Butler County, Ohio

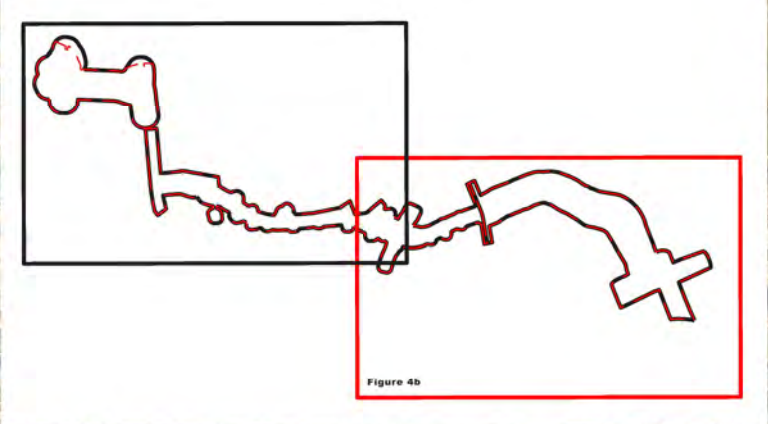
Figure 4b
Suitable Wooded Habitat

Suitable Wooded Habitat:

- = Within 100 feet of Edge of Pavement or Active Rail Line
- = Between 100 feet and 300 feet of Edge of Pavement or Active Rail Line
- = Within 50 feet of Stream with Drainage Area Greater Than 1 Square Mile
- = Beyond 300 feet of Edge of Pavement or Active Rail Line

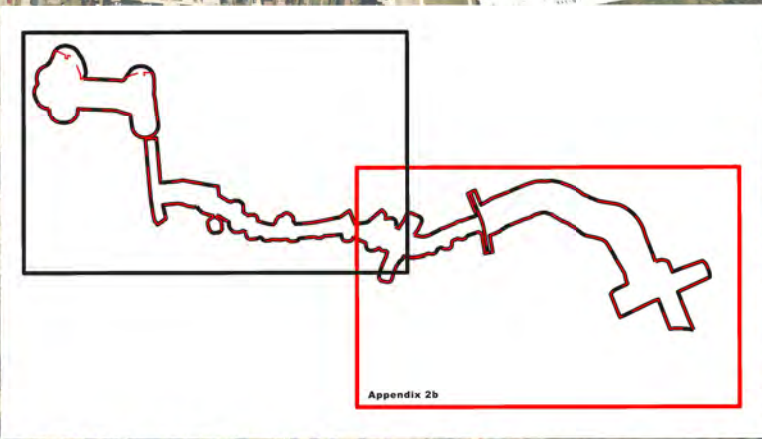
- = Developed High Intensity
- = Developed Medium Intensity
- = Developed Low Intensity
- = Developed Open Space
- = Upland Forest
- = Floodplain Forest
- = Scrub/Shrub
- = Grassland/Herbaceous
- = Open Water
- = Marsh

1 = Photograph Number and Location

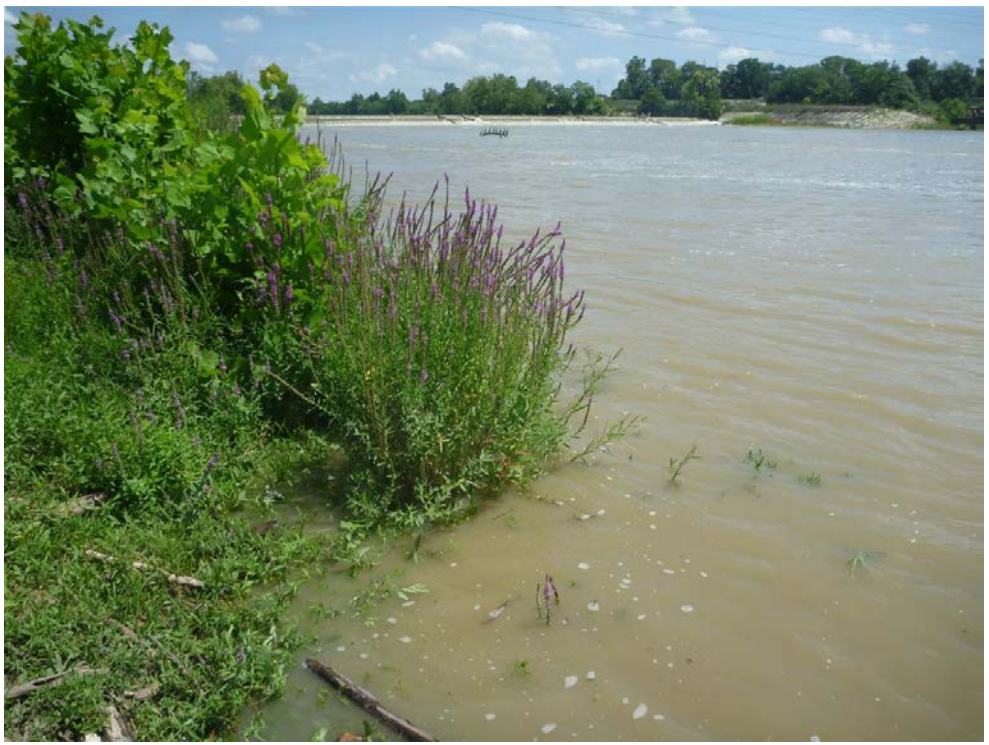
Photograph ID: 1

Photo Location: 1	
Direction: Northeast	
Survey Date: 8/7/2024	
Comments: Great Miami River, perennial, facing upstream.

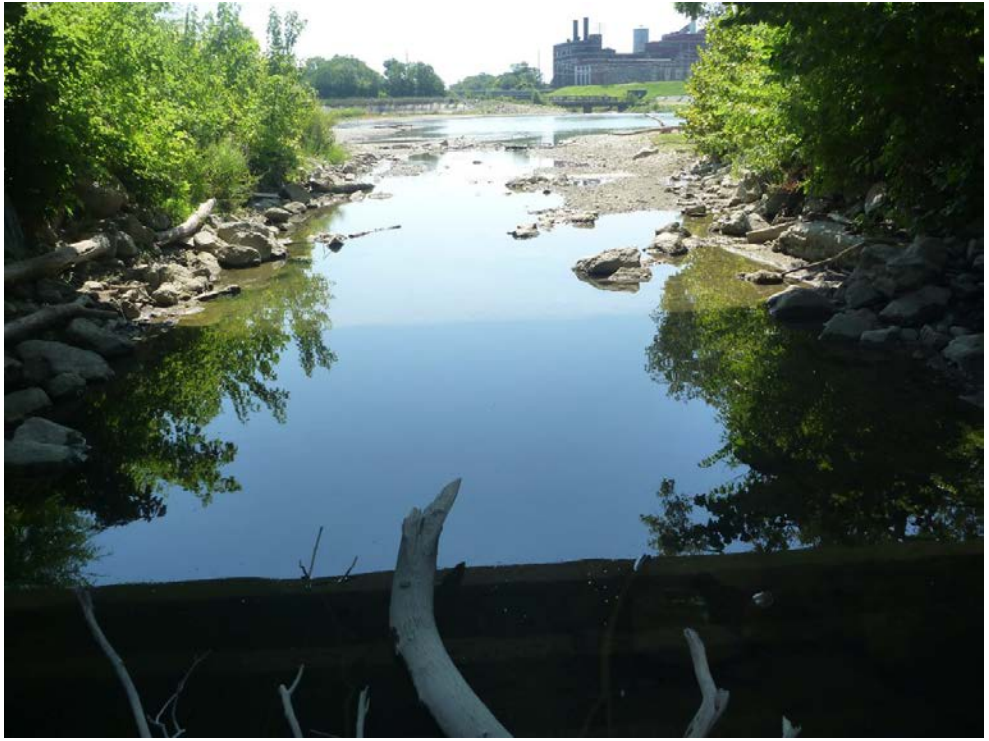
Photograph ID: 5

Photo Location: 2	
Direction: Southeast	
Survey Date: 8/14/2024	
Comments: Twomile Creek, perennial, facing downstream.

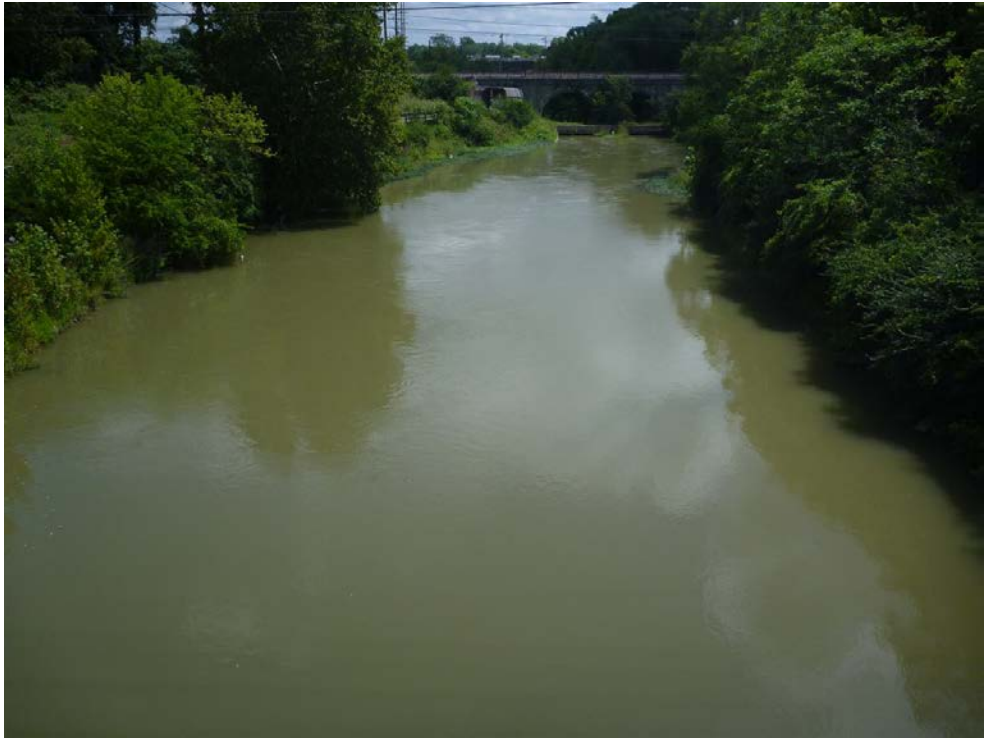
Photograph ID: 7

Photo Location: 3	
Direction: East	
Survey Date: 8/7/2024	
Comments: Hydraulic Canal, perennial, facing upstream.

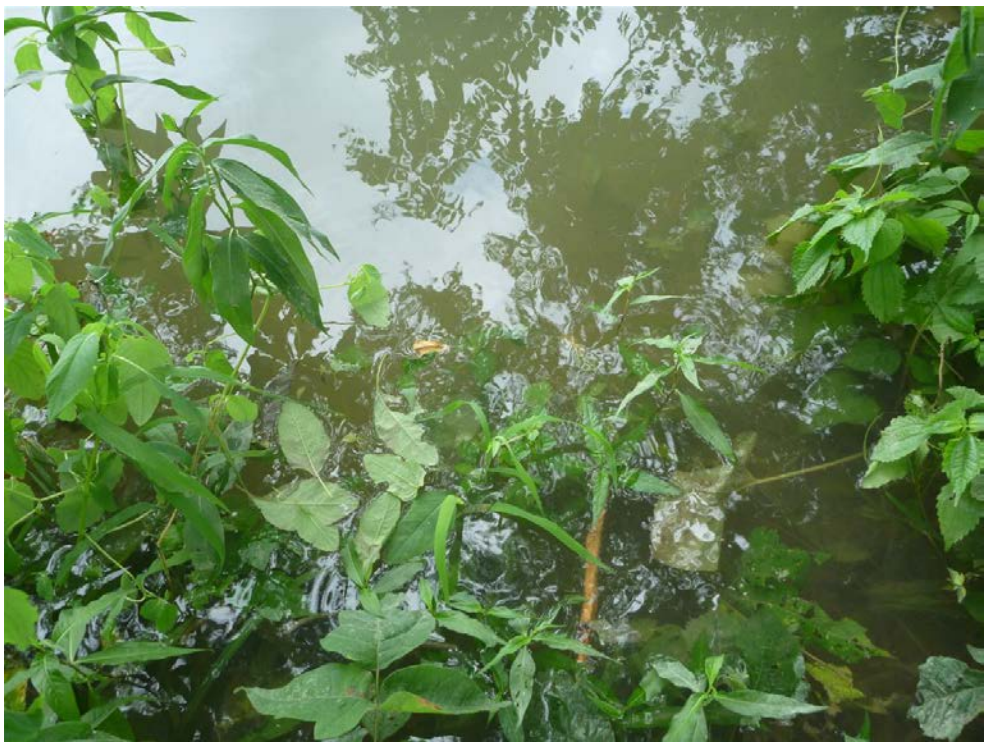
Photograph ID: 9

Photo Location: 3	
Direction: Down	
Survey Date: 8/7/2024	
Comments: Hydraulic Canal, perennial, typical substrates.

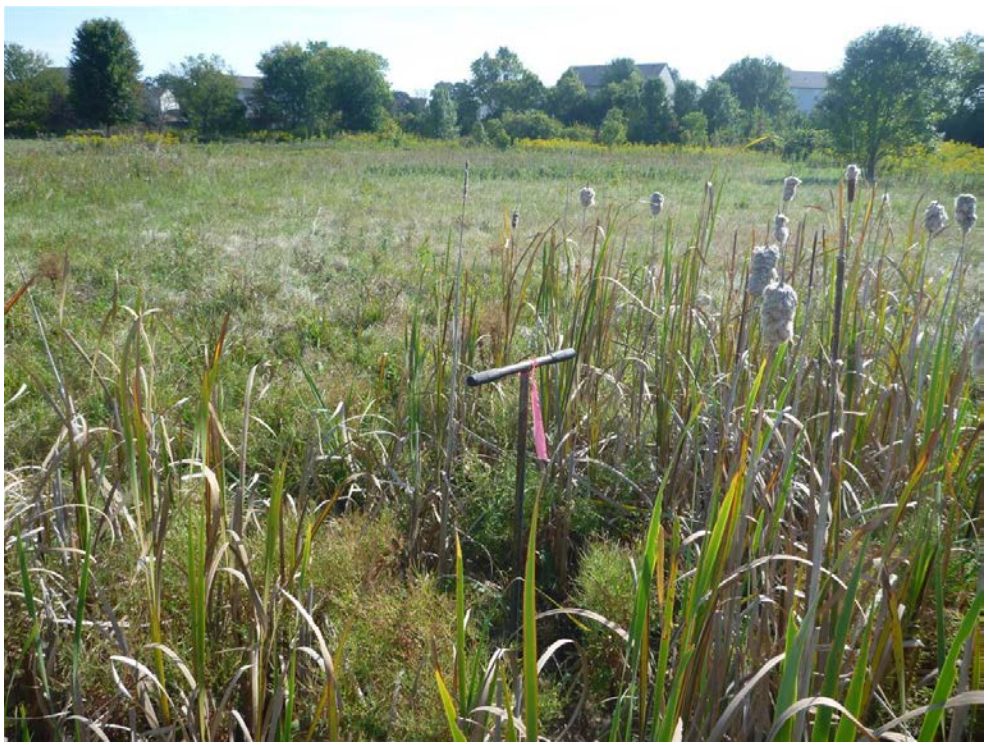
Photograph ID: 11

Photo Location: 4	
Direction: East	
Survey Date: 9/19/2024	
Comments: Wetland A, Sample Point P1.

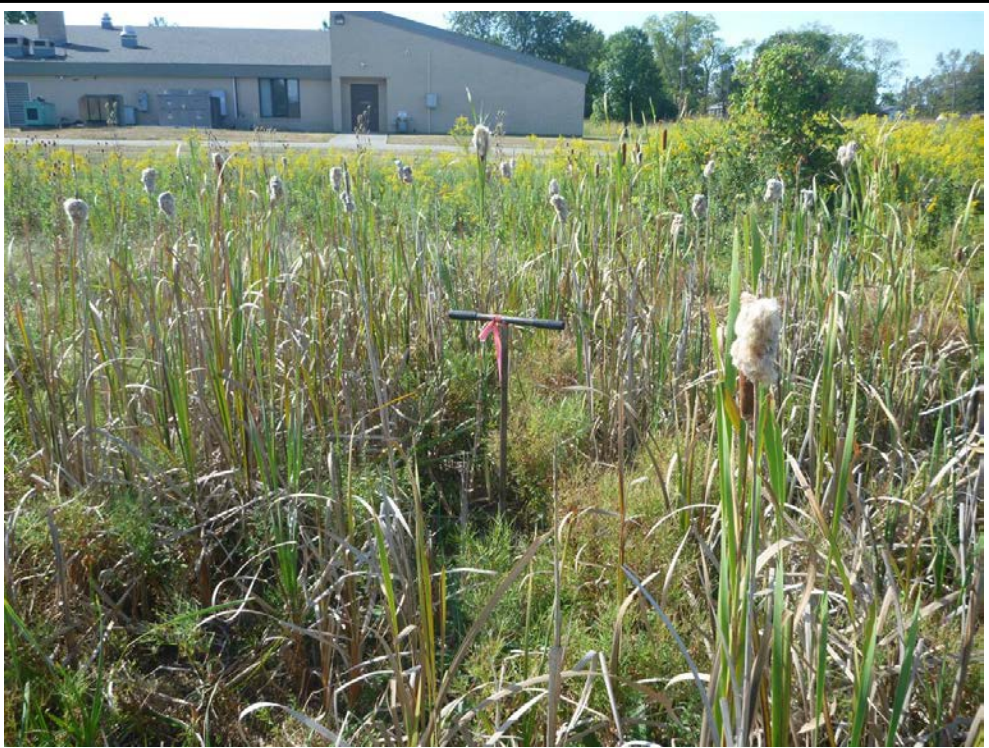
Photograph ID: 12

Photo Location: 4	
Direction: South	
Survey Date: 9/19/2024	
Comments: Wetland A, Sample Point P1.

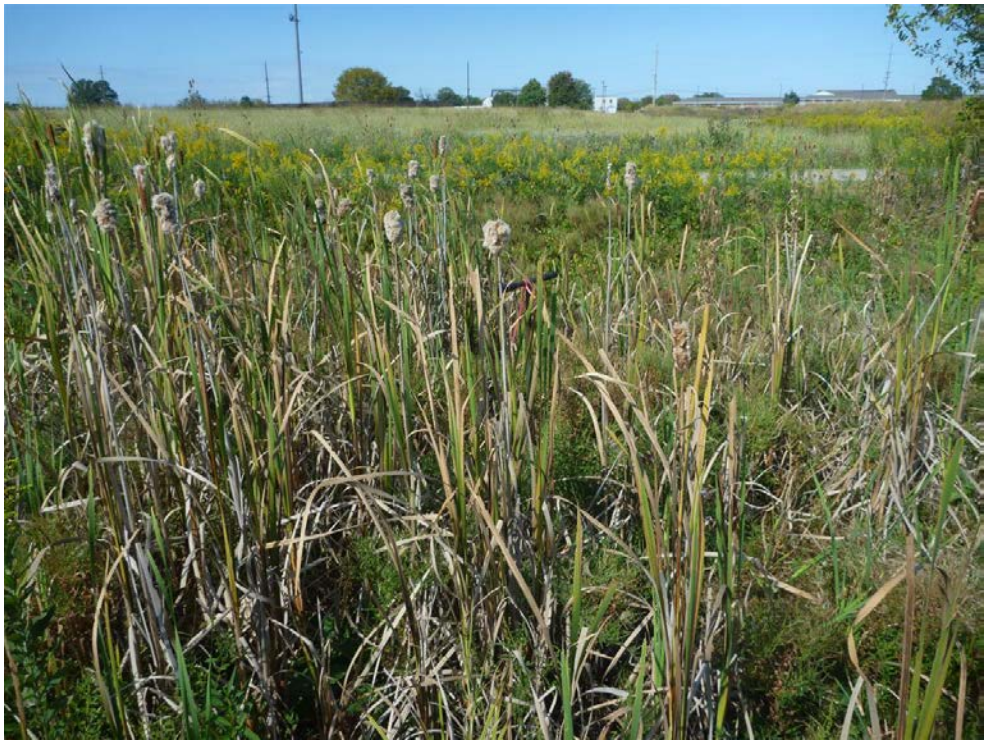
Photograph ID: 13

Photo Location: 4	
Direction: West	
Survey Date: 9/19/2024	
Comments: Wetland A, Sample Point P1.

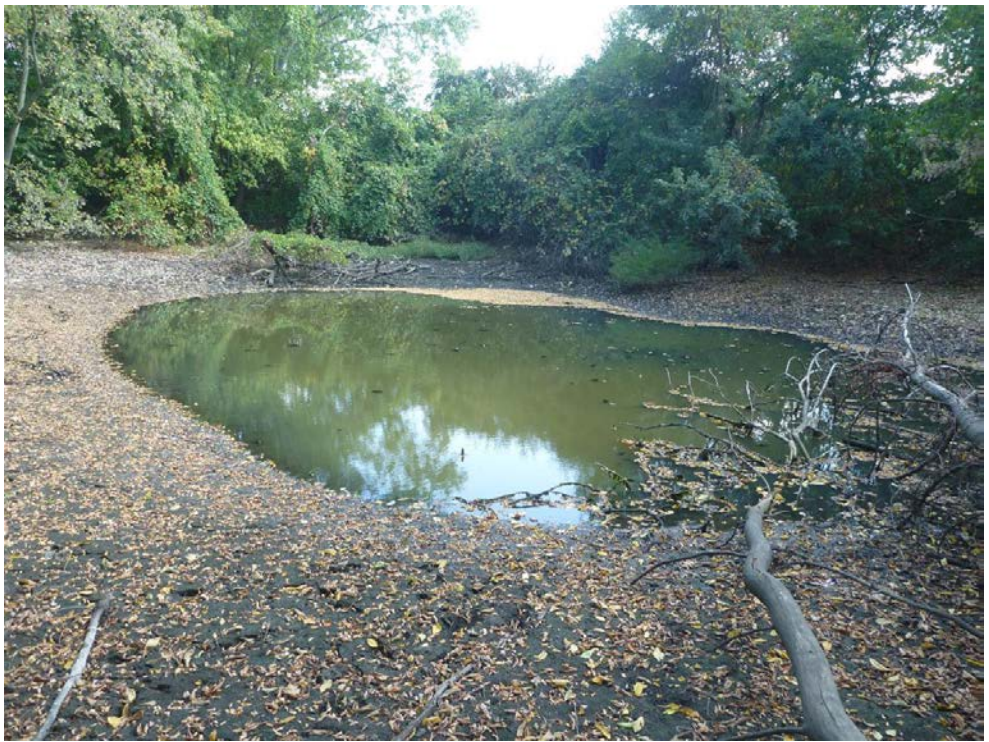
Photograph ID: 14

Photo Location: 5	
Direction: Southeast	
Survey Date: 9/19/2024	
Comments: Pond 1.

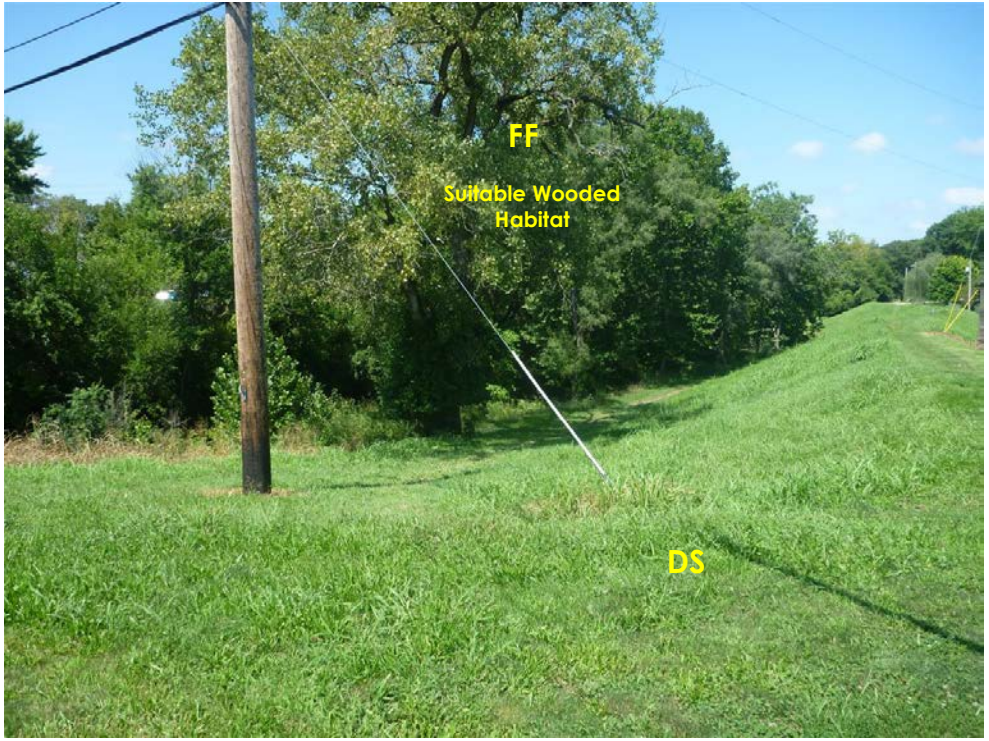
Photograph ID: 17

Photo Location: 8	
Direction: Northwest	
Survey Date: 8/7/2024	
Comments: Developed Open Space (DS) and Floodplain Forest (FF) vegetative communities.

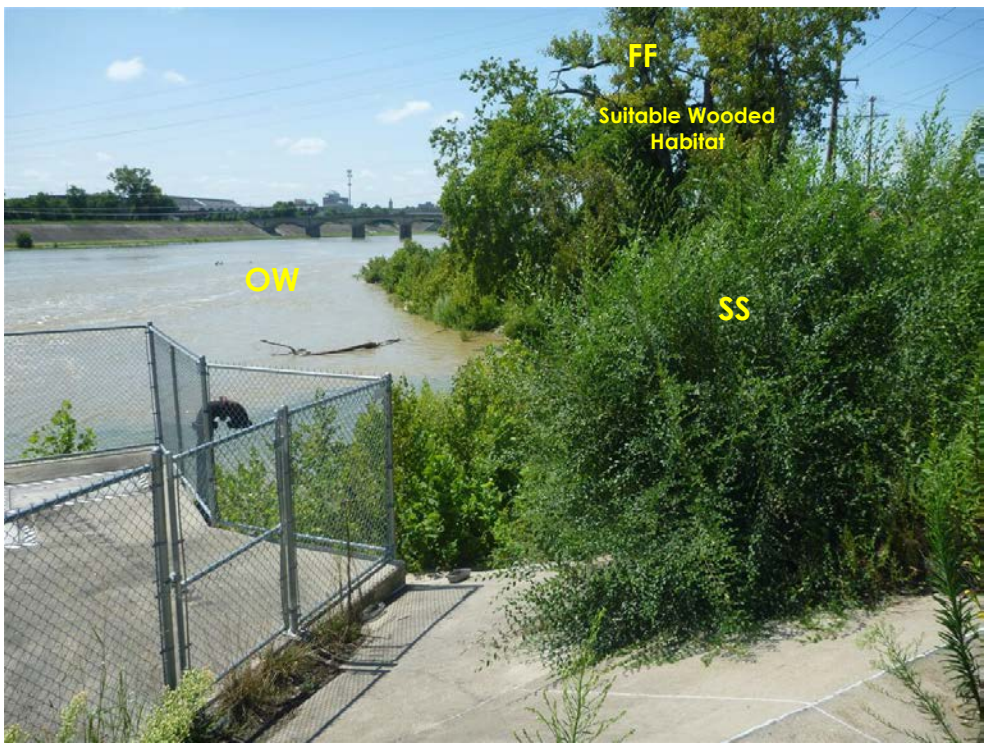
Photograph ID: 18

Photo Location: 9	
Direction: South	
Survey Date: 8/7/2024	
Comments: Scrub/Shrub (SS), Floodplain Forest (FF), and Open Water (OW) vegetative communities.

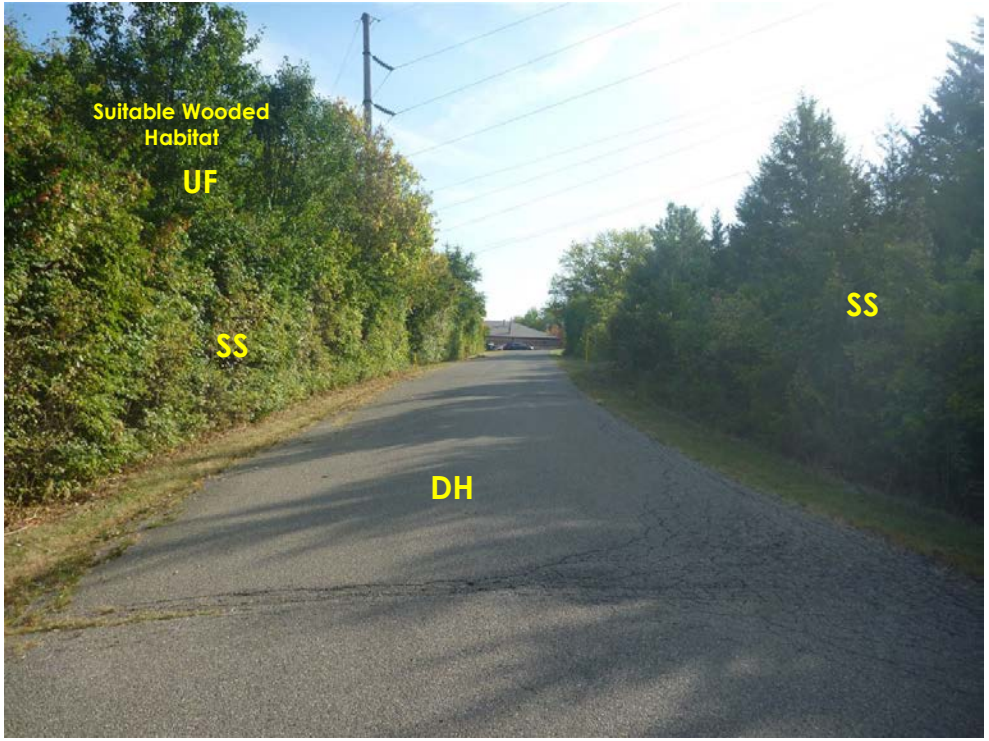
Photograph ID: 19

Photo Location: 10	
Direction: Northeast	
Survey Date: 9/19/2024	
Comments: Developed High Intensity (DH), Scrub/Shrub (SS), and Upland Forest (UF) vegetative communities.

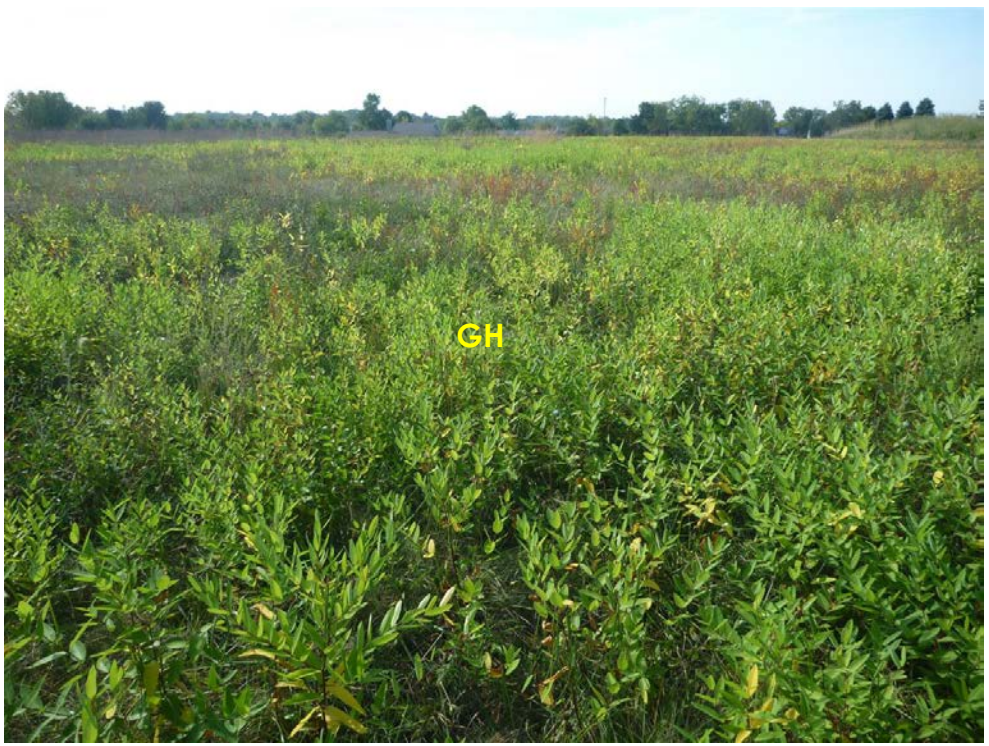
Photograph ID: 20

Photo Location: 11	
Direction: South	
Survey Date: 9/19/2024	
Comments: Grassland/Herbaceous (GH) vegetative community.

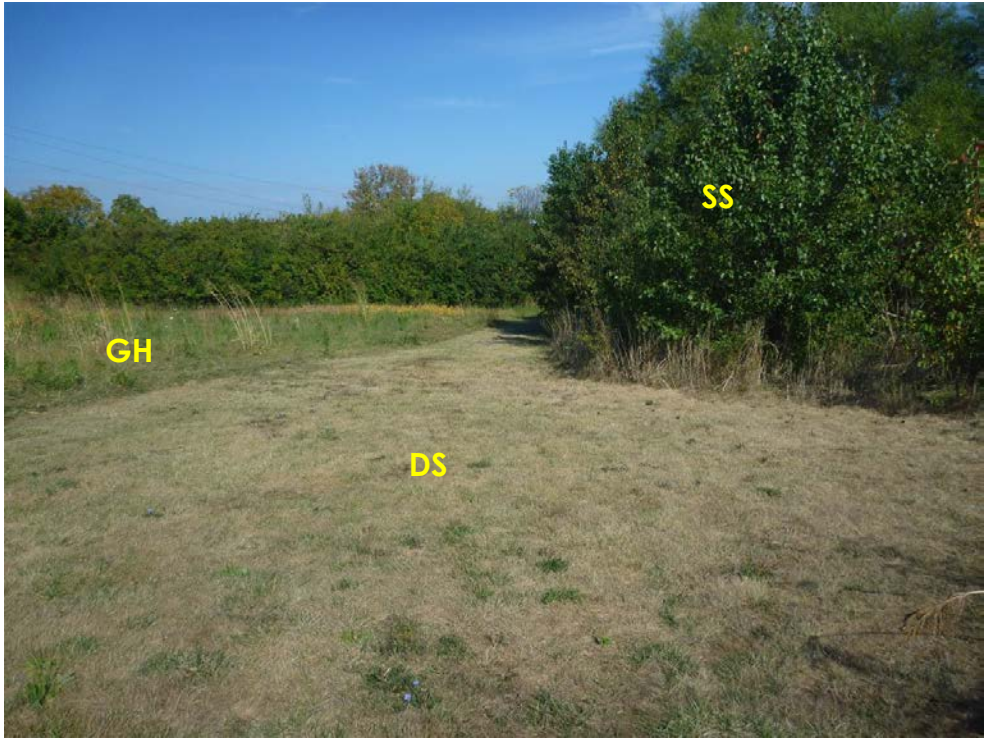
Photograph ID: 21

Photo Location: 12	
Direction: Northwest	
Survey Date: 9/19/2024	
Comments: Developed Open Space (DS), Scrub/Shrub (SS), and Grassland/Herbaceous (GH) vegetative communities.

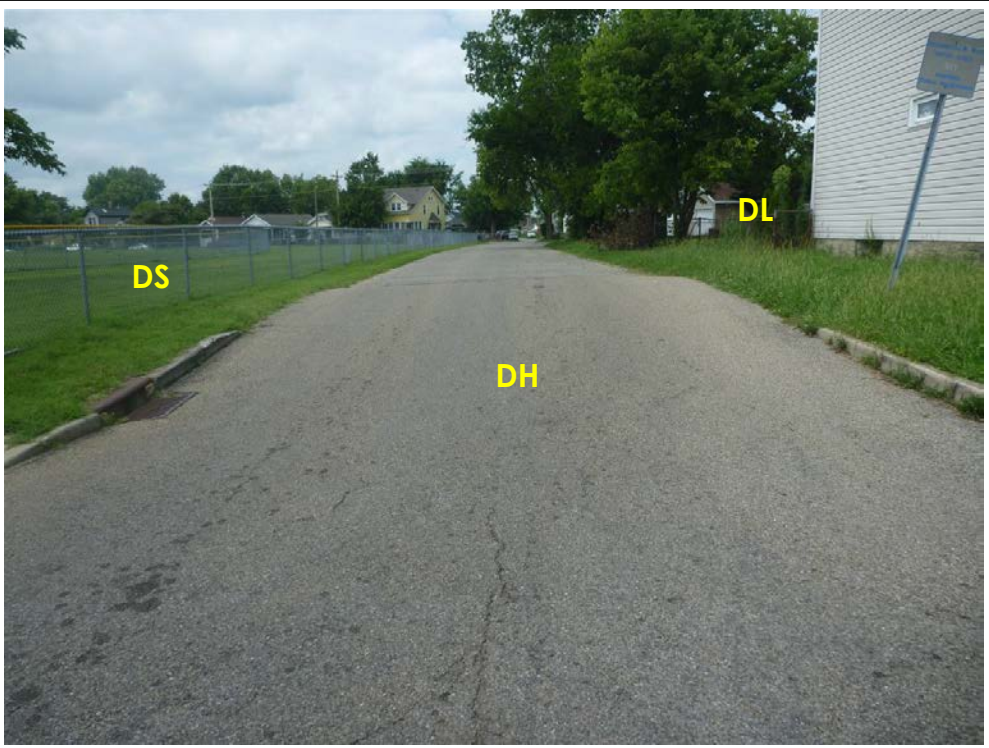
Photograph ID: 22

Photo Location: 13	
Direction: West	
Survey Date: 8/8/2024	
Comments: Developed Open Space (DS), Developed High Intensity (DH), and Developed Low Intensity (DL) vegetative communities.

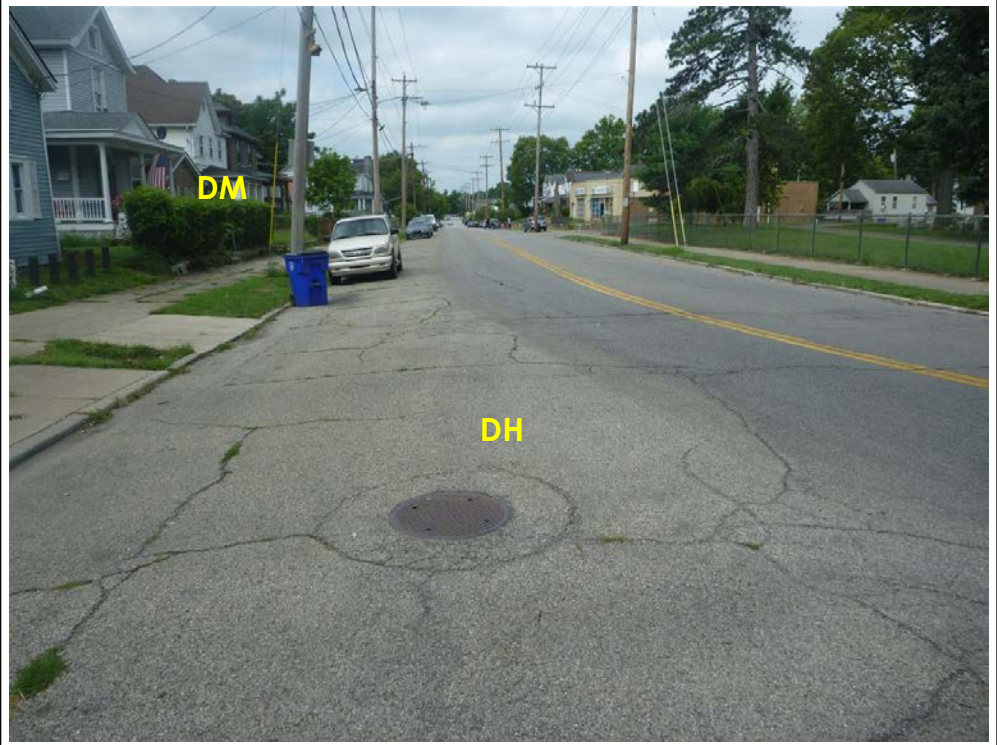
Photograph ID: 23

Comments:
Developed High Intensity (DH) and Developed Medium Intensity (DM) vegetative communities.

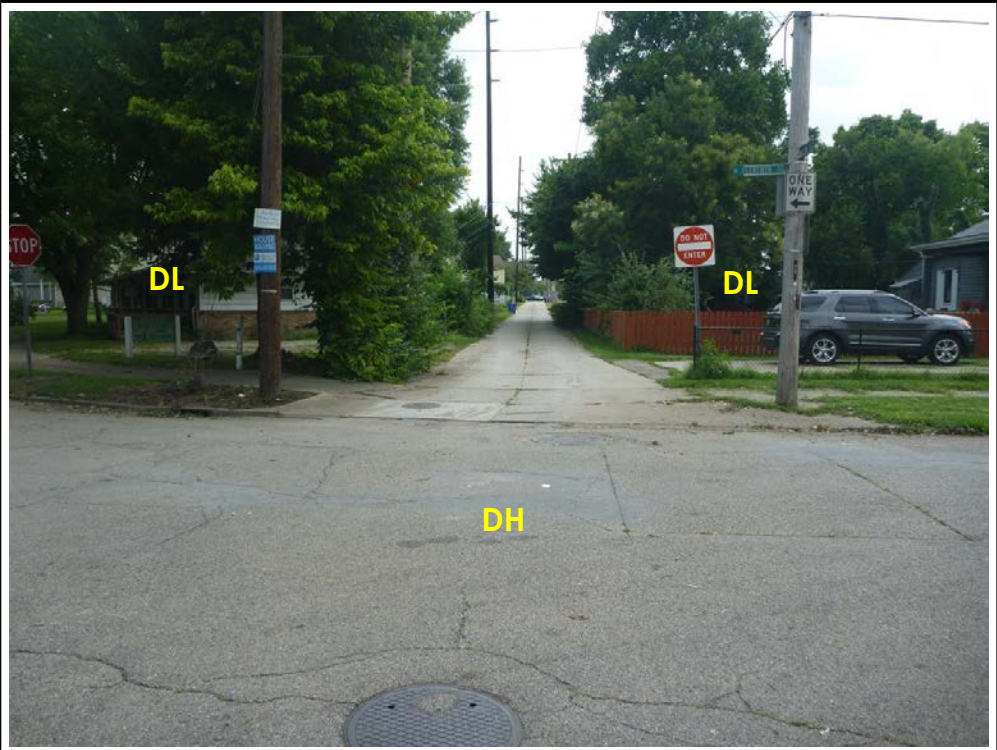
Photograph ID: 24

Comments:
Developed High Intensity (DH) and Developed Low Intensity (DL) vegetative communities.

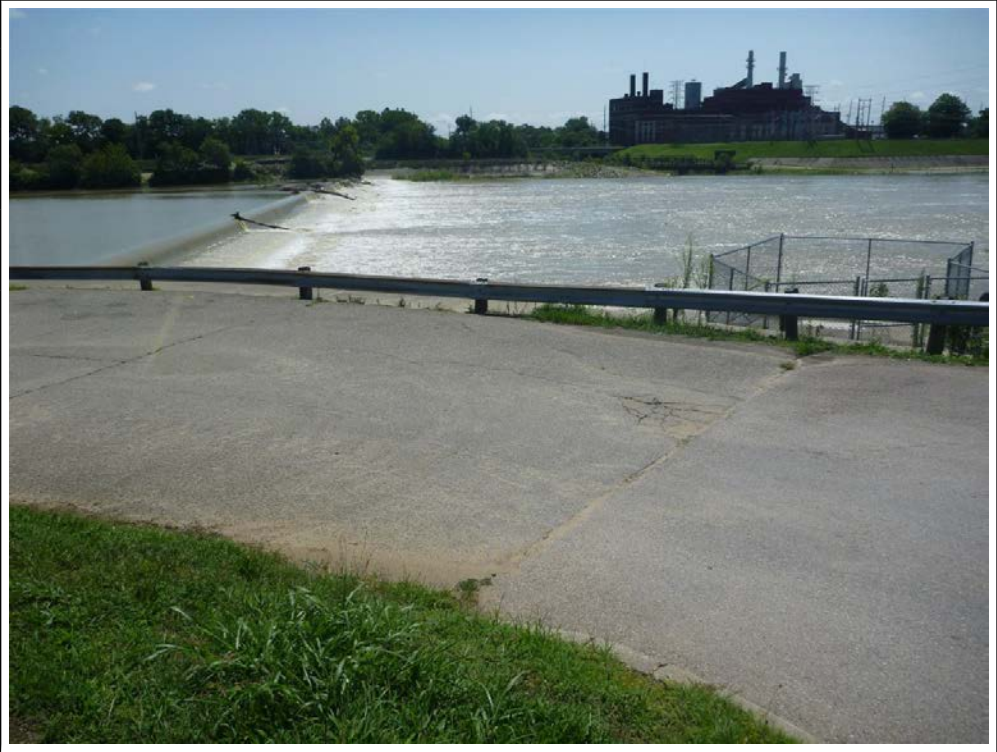
Photograph ID: 25

Comments:
Great Miami River dam
from Combs Park driveway.

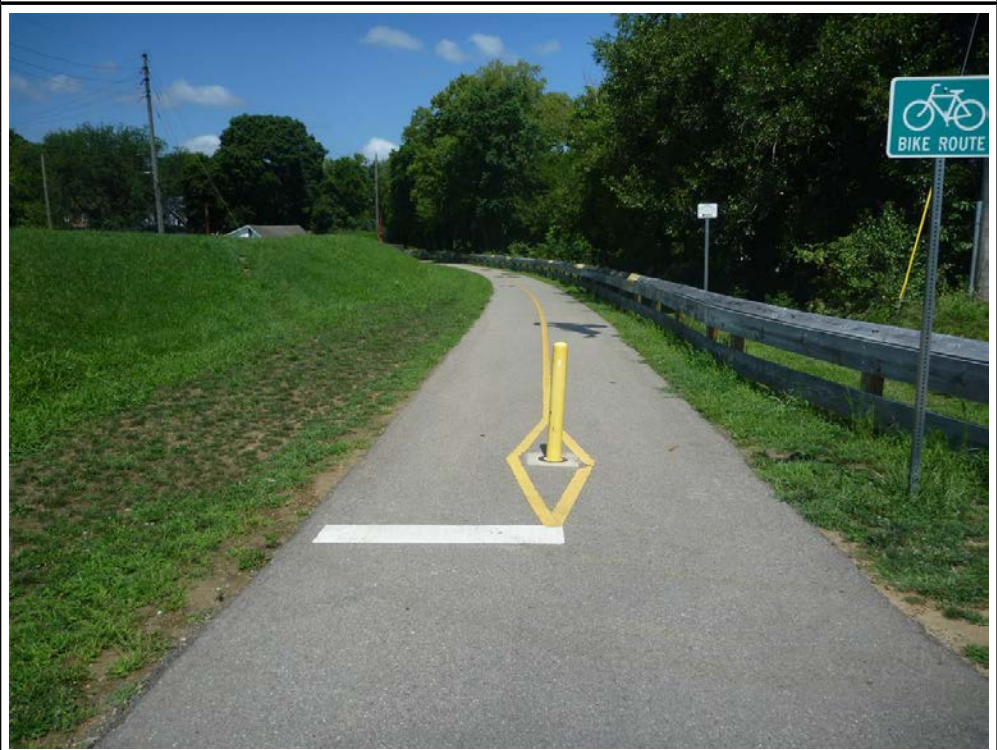
Photograph ID: 27	 
Photo Location: 17	
Direction: Southwest	
Survey Date: 8/7/2024	
Comments: View of Riverview Food Mart and North B Street.

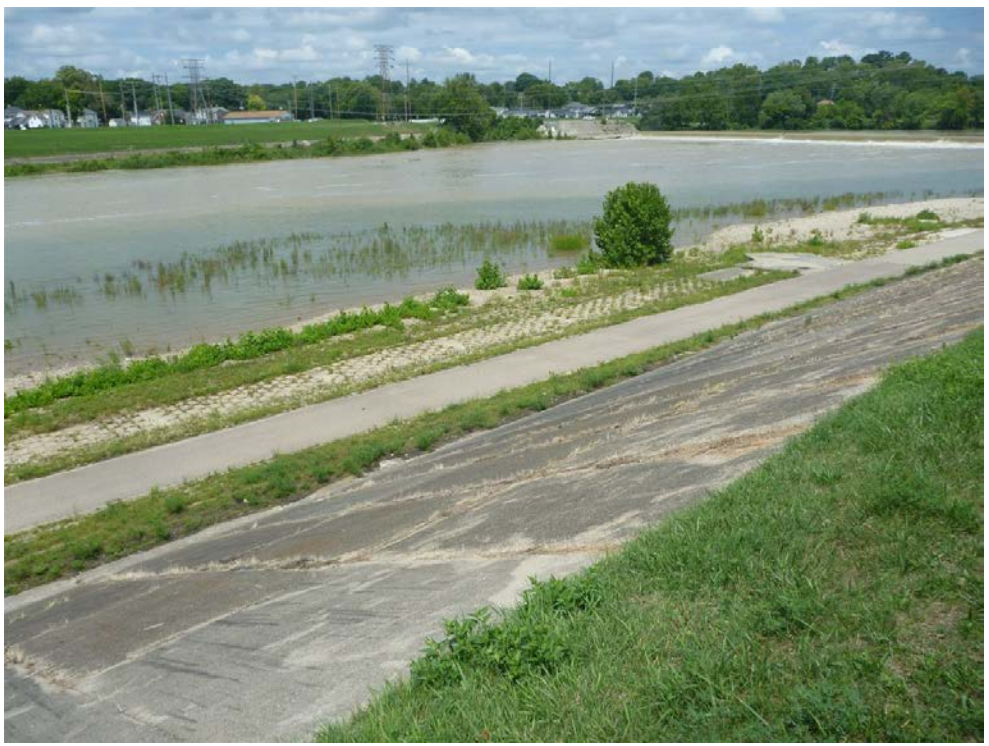
Photograph ID: 30

Photo Location: 20	
Direction: North	
Survey Date: 8/7/2024	
Comments: Great Miami River Trail and east bank floodwall.

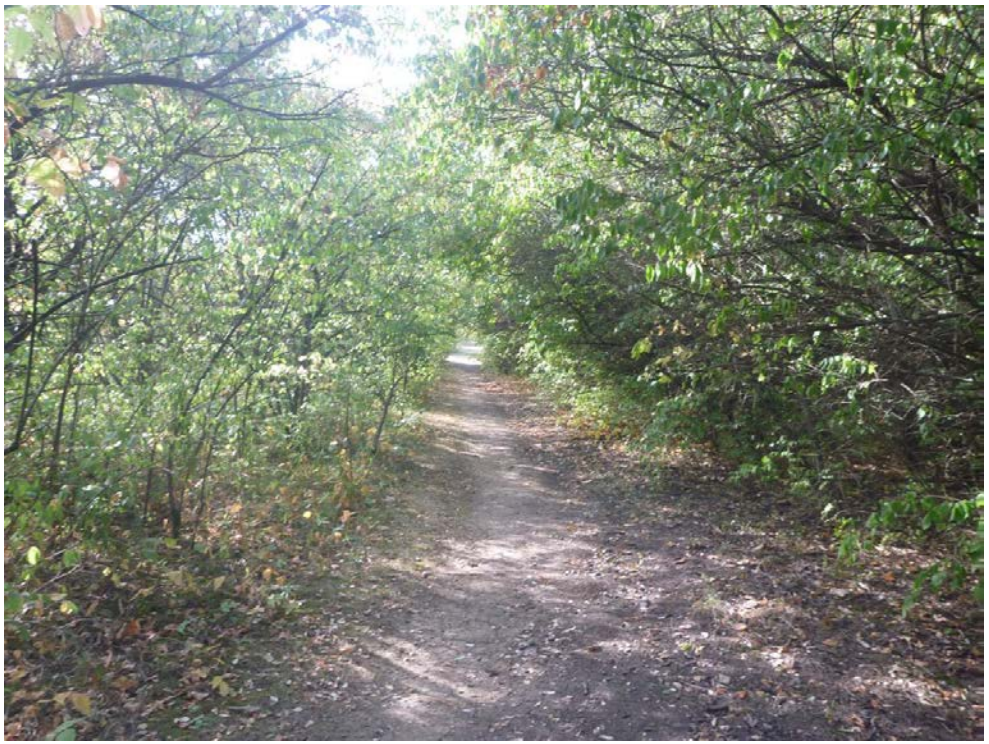
Photograph ID: 44

Photo Location: 33	
Direction: South	
Survey Date: 9/19/2024	
Comments: Maintained trail for the Animal Friends Humane Society.
